MULTIDISCIPLINE ANALYSIS OF A FATAL LPG TANK RUPTURE

Bernard Ross

Failure Analysis Associates
149 Commonwealth Drive
Menlo Park, California 94025

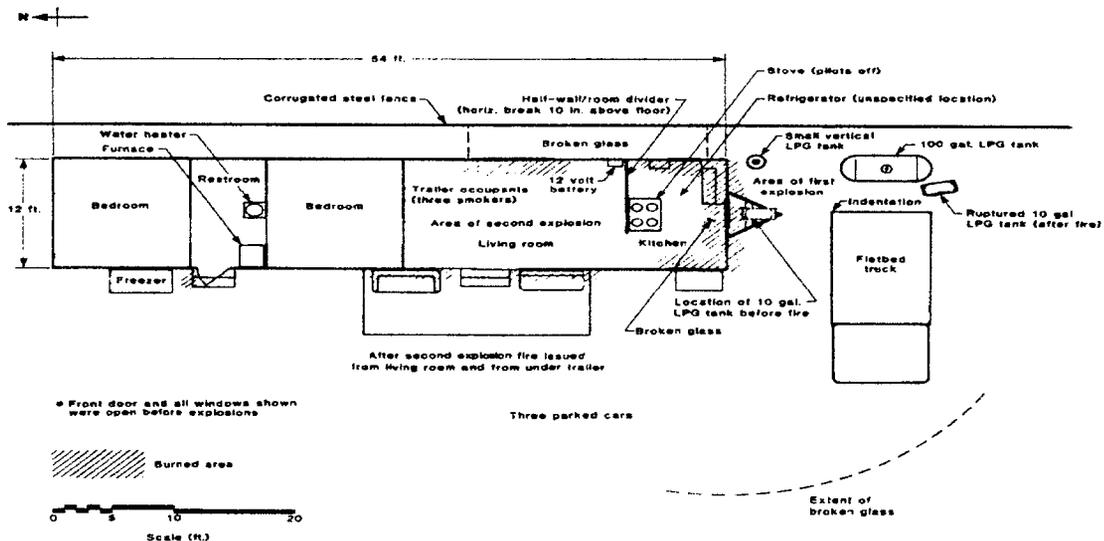
Figure 1: Accident Scene

Two large bangs were heard by surviving occupants of the trailer. Obviously, the first bang was rupture of the tank, and the second bang, deflagration of the released propane cloud which readily found source(s) of ignition according to Murphy's Law. The unsecured tank took off as a jet powered projectile and smashed into a nearby flat bed truck causing the combination vapor discharge hand valve with integral pressure relief valve to be broken off traumatically at its threaded connection with the tank. The layout of the accident scene is shown in Figure 1.

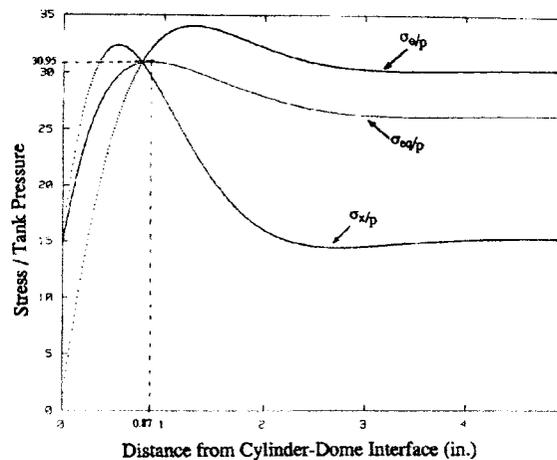
Figure 6: Nominal (full penetration) Stress Profiles for LPG Tank

Results of these calculations are presented in terms of the nondimensional stress-to-tank pressure ratio and shown in Figure 6. An interesting feature of the discontinuity stress profiles is fact that they attain maximum value(s) at a standoff distance from the circumferential joint (i.e., interface) itself. The curve for σ_{eq} in the plot represents the Von Mises equivalent stress which quantity is normally used in conventional failure analysis for a ductile material. A value of $\sigma_{eq} = 30.95 p$ at 0.87 in. distance from the cylinder-dome interface was determined.

Using the tensile strength value realized for the steel skid plate tank material and the Von Mises failure criterion, an as-designed burst pressure of 1615 psi was predicted. Here the material strength criterion used for failure was the flow stress; that is, the average stress between Tresca yield ($0.5 \sigma_{ult}$) and ultimate tensile strength (σ_{ult}). A flow stress value of 50 ksi was obtained for the **tank shell**.

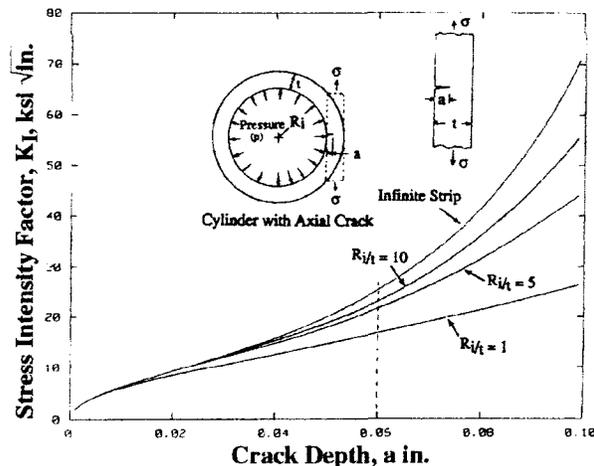
Figure 7: Stress Intensity Factor, K_I , for Cylinder with Axial Crack

For the tank at issue, the smallest weld penetration was 0.105 in. With a nominal wall thickness of 0.162 in., the deepest crack would be 0.057 in. Figure 7 shows that for crack depths up to 0.060 in. the strip K_I solution provides a reasonable estimate (within 10%) of the cylinder K_I solutions for $R/t > 10$ without being overly conservative.

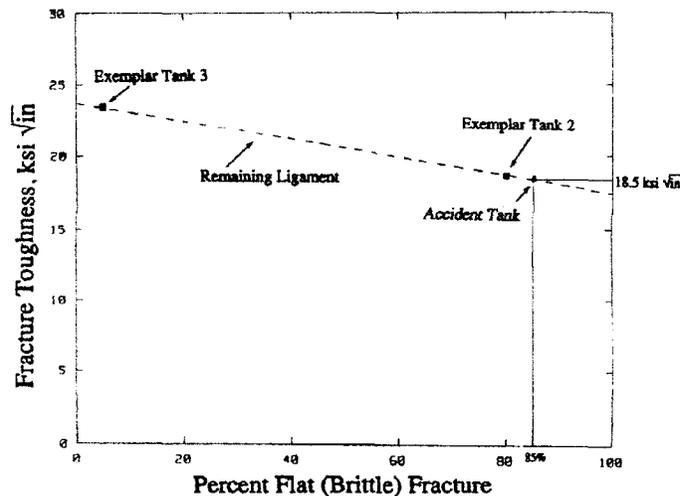
Figure 8. Fracture Toughness vs. Fracture Mode

$K_I = 18.7 \text{ ksi } \sqrt{\text{in}}$ (80% flat fracture) for Tank #2 and $K_I = 23.4 \text{ ksi } \sqrt{\text{in}}$ (5% flat fracture) for Tank #3 respectively. These data points are represented in the plot of Figure 8.

The ensuing linear empirical relationship between fracture toughness and percent flat fracture enabled a prediction for burst pressure of the accident tank. Specifically, an 85% flat fracture topology was ascribed to the burst accident tank based on visual observation of SEM photographs. Reference to the test data plot of Figure 8 indicates that for 85% flat fracture a K_{IC} value of 18.5 ksi is predicted for the accident tank fracture toughness. However, the remaining ligament solution was not appropriate for the accident tank since it did not contain the significant weld crown of the shop fabricated exemplar tanks. Therefore, the previously mentioned single edge crack in an infinite strip solution was invoked. Apropos, the governing relation for stress intensity factor as a function of pressure became $K_I = 22.8p$ for an average crack depth of 0.054 in. which, in turn, implied a burst pressure of $P = 811$ psi.

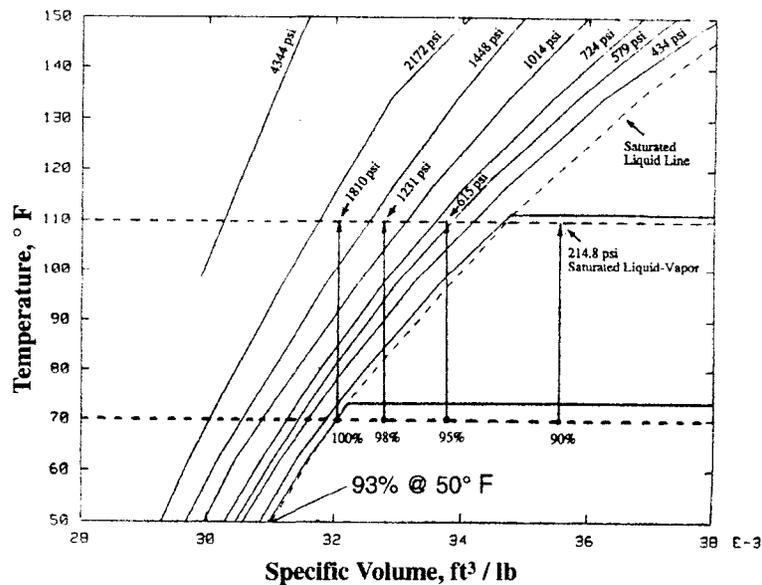
Figure 10. Temperature-Volume Diagram for Propane

Figure 10 demonstrates that if the tank were initially filled to 95% capacity at 70°F and the temperature increased to 110°F, the propane would become a compressed liquid and a pressure of 615 psi could be realized. However, when an LPG tank is overfilled (more than 80%) it is not the maximum temperature that is solely important but also the differential change experienced beyond the filling temperature. If the tank were filled at a lower temperature (say 50°F) the predicted pressure of 537 psi required to rupture the tank would be realized at an aberrant fill capacity of 92-93% which could readily result from the faulty outage tube length.
