MULTIDISCIPLINE ANALYSIS OF A FATAL LPG TANK RUPTURE

Bernard Ross

Failure Analysis Associates
149 Commonwealth Drive
Menlo Park, California 94025

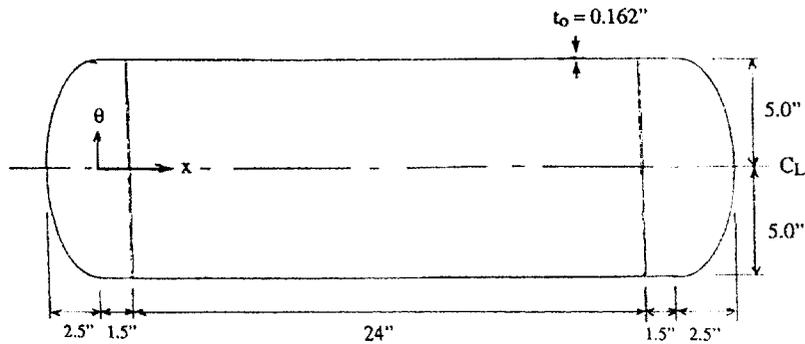
Geometry of Tank

Results of these calculations are presented in terms of the nondimensional stress-to-tank pressure ratio and shown in Figure 6. An interesting feature of the discontinuity stress profiles is fact that they attain maximum value(s) at a standoff distance from the circumferential joint (i.e., interface) itself. The curve for σ_{eq} in the plot represents the Von Mises equivalent stress which quantity is normally used in conventional failure analysis for a ductile material. A value of $\sigma_{eq} = 30.95 p$ at 0.87 in. distance from the cylinder-dome interface was determined.

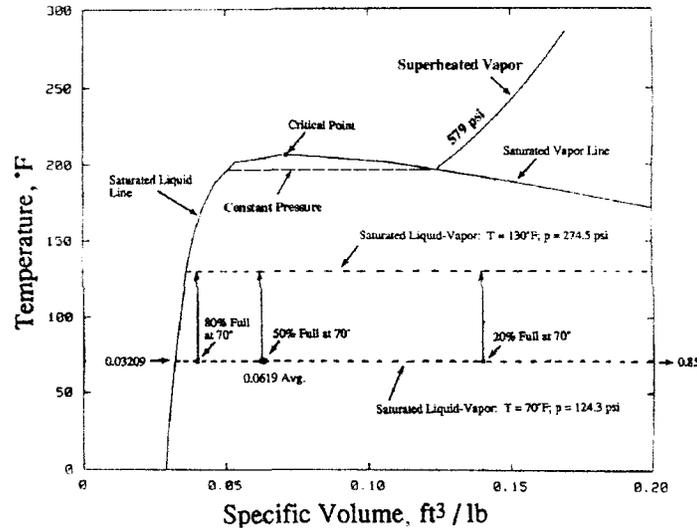
Figure 9. Temperature-Volume Diagram for Propane

Temperature-Pressure Behavior of Propane: The thermodynamic relationships between temperature, pressure, and volume for propane were obtained from a reference handbook. These relationships are presented in Figure 9 as a Temperature vs. Specific Volume diagram with lines of constant pressures as a parametric variable. Figure 9 shows the three phases of propane; namely, saturated liquid-vapor, saturated liquid and superheated vapor. To the left of the saturated liquid line, and below the critical temperature, propane is a compressed liquid.

the vapor above the liquid will be at the saturation pressure, 124.3 psi (Figure 9). As the temperature increases to 130°F, some of the liquid propane boils to raise the vapor pressure while vapor also condenses due to the increased pressure. The equilibrium point is the saturation pressure for propane at 130°F (i.e., the maximum rated operating pressure) which turns out to be 274.5°F (i.e., the relief valve setting).

An important observation is that as the initial volume of liquid propane in the tank increases (i.e., average specific volume decreases), the danger of exiting the saturated liquid-vapor phase and entering the compressed liquid phase becomes possible. It is for this reason that LPG tanks should not be filled over 80% capacity. In the saturated liquid region, small changes in temperature can result in large changes in pressure. To portray the potential rise in pressure that can occur from overfilling (i.e., more than 80%) an LPG tank and then subjecting the tank to temperature increase, the compressed liquid region for propane is expanded in Figure 10. The pressures attained when the temperature increases to 110°F (i.e., approximate surface temperature when tank exploded) are shown.
